Single Equipment Full Report

For: **BC-1 Distillate Pump**

Measurements from 2017-12-14 to 2018-04-07

Generated On **2018-05-08**
Generated By **Petar Spaseski**

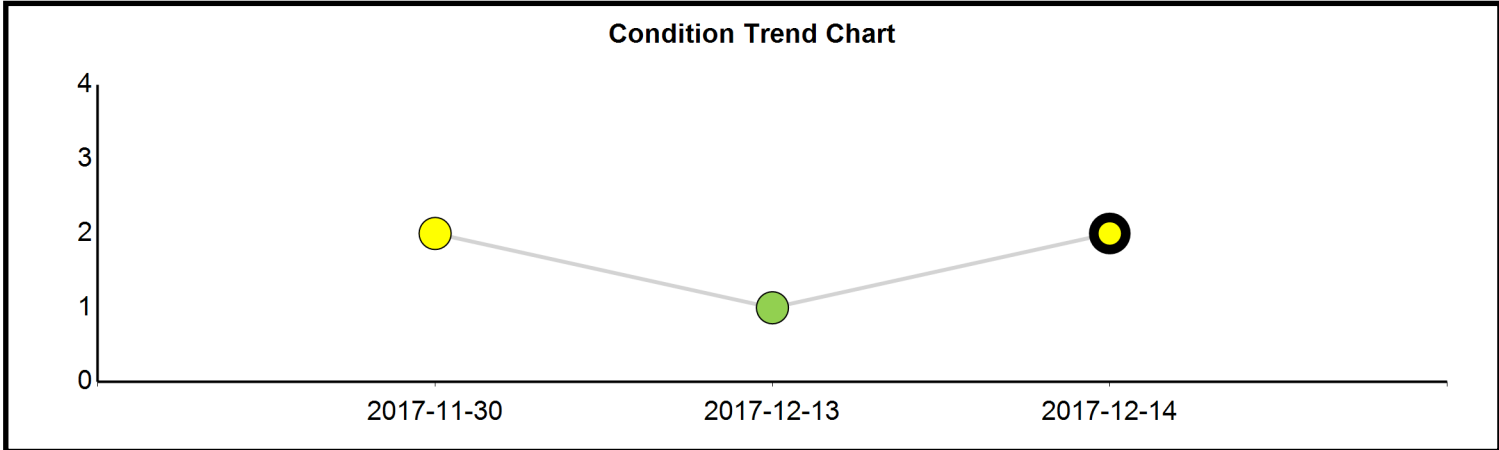
Condition and Recommendations

For Measurements done	Condition
From 2017-12-14 to 2018-04-07	(2) Initial Fault detected (P)

Overall velocity levels were acceptable this survey (5.7mm/s RMS at NDE), with the dominant vibration primarily at shaft rotation speed. Rotational vibration levels have remained relatively stable since the last survey (22 Dec 2015). Very low level vibration at 231Hz was evident, which may indicate an initial defect on the NDE bearing inner race. This has remained stable since last survey. The sensor at the drive end was giving a faulty signal.

Action	Failure Type	Failure Mode	Severity	Action Type	Urgency
Monitor for any further deterioration in balance or bearing condition.	SPO	BRF		FA	ANO
Inspect sensor on DE bearing and repair/replace as required.	SYS	BRRRD		LE	AWC
