Single Equipment Full Report

For: **BC-1 Distillate Pump**

Measurements from 2017-12-14 to 2018-04-07

Generated On **2018-05-08**
Generated By **Petar Spaseski**

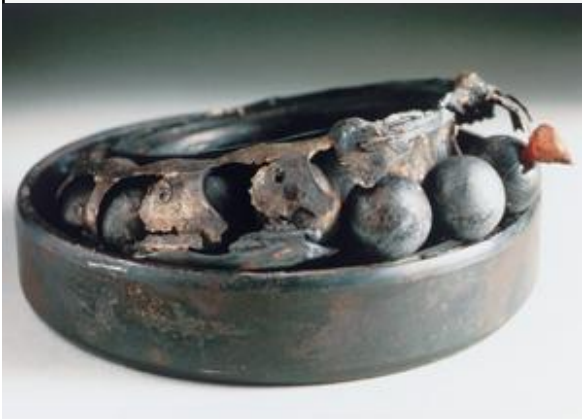
054ac798-0778-4b7e-8699-9002c46f339e_1-22-14.jpeg

Overall velocity levels were acceptable this survey (5.7mm/s RMS at NDE), with the dominant vibration primarily at shaft rotation speed. Rotational vibration levels have remained relatively stable since the last survey (22 Dec 2015). Very low level vibration at 231Hz was evident, which may indicate an initial defect on the NDE bearing inner race. This has remained stable since last survey. The sensor at the drive end was giving a faulty signal.

Action	Failure Type	Failure Mode	Severity	Action Type	Urgency
Monitor for any further deterioration in balance or bearing condition.	SPO	BRF		FA	ANO
Inspect sensor on DE bearing and repair/replace as required.	SYS	BRRRD		LE	AWC
